Rest Area ADA Compliance

Outdated ADA Standards at Rest Areas Pose Risk to Public

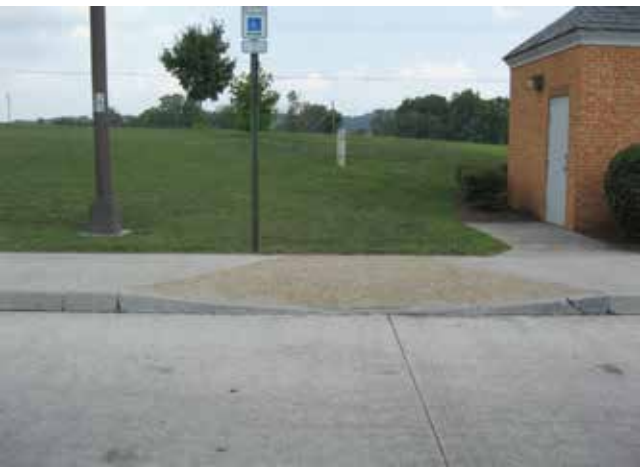
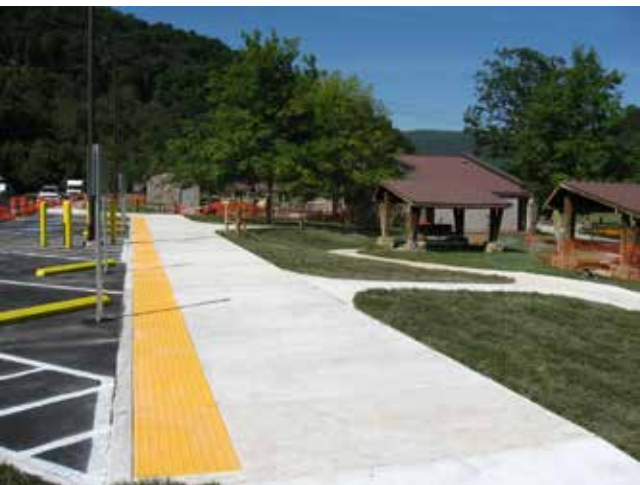
38 curb ramps and 16 associated pathways located throughout 14 VDOT safety rest areas did not meet current Americans with Disabilities Act (ADA) standards.

We found noncompliant curb ramps and some pathways at every rest area we inspected. We calculated proper slopes and grades to meet current ADA standards for slope, landings, and turning movements. This determined the optimal placement for the curbs, ramps, and pathways. In some cases, that meant moving the current ramp location to a more favorable location or increasing the amount of sidewalk width or path length. In some instances, we also adjusted the parking stall configuration to maximize and efficiently utilize handicap parking.

PILLAR identified the most appropriate location and correct ADA standard to achieve compliance with minimal disruption. Finally, based on the information collected from our surveyors, we determined that sites and standards were achievable.
